Manhole Inspection Summary

Manhole # S19Y__004MH

Insp Date: **6/5/08 9:07 AM**

Location Address: **1808 sexton st**

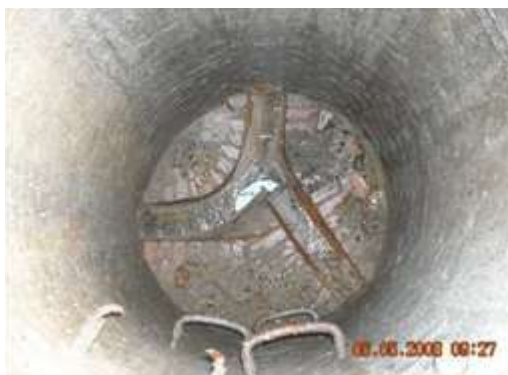
Defect 4

Condition: ☒ Sound ☐ Cracked ☐ Root Intrusion ☐ Deteriorated ☐ Leaks ☐ Debris

bench debris

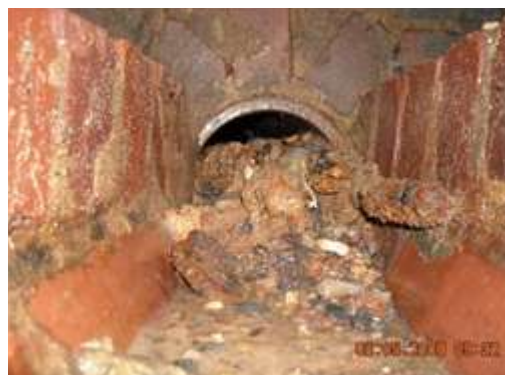
Defect 5

Condition: ☐ Sound ☐ Cracked ☐ Root Intrusion ☐ Deteriorated ☐ Leaks ☒ **Debris**

channel cond debris

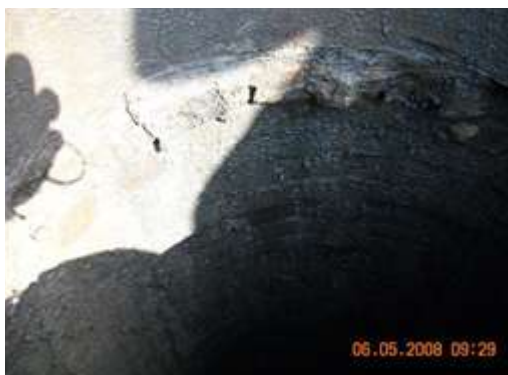
Defect 4

Condition: ☐ Sound ☐ Cracked ☐ Root Intrusion ☐ Loose Brick ☒ **Deteriorated**

Infiltration: ☐ None ☒ **Joint** ☐ Cracks ☐ Mortar ☐ Roots ☐ Wall

deteriorated chimney, infiltration @ chimney/frame joint

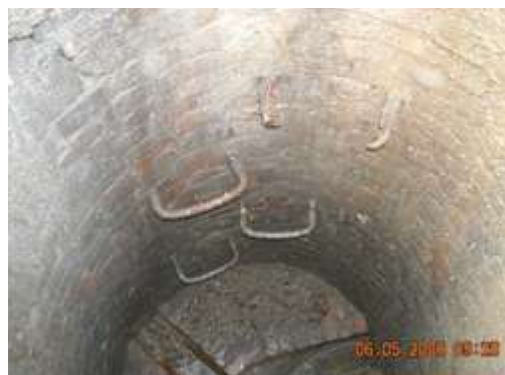
Steps Count: **3** Missing: **2** ☒ **Corroded**

corroded & missing steps

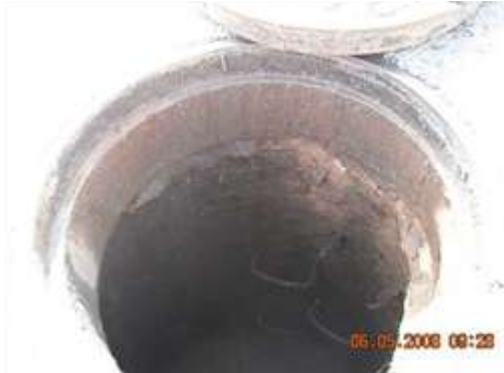
Defect 2

Frame Offset: **1** (in.) Condition: ☐ Sound ☐ Cracked ☒ **Leaks**

frame leaks

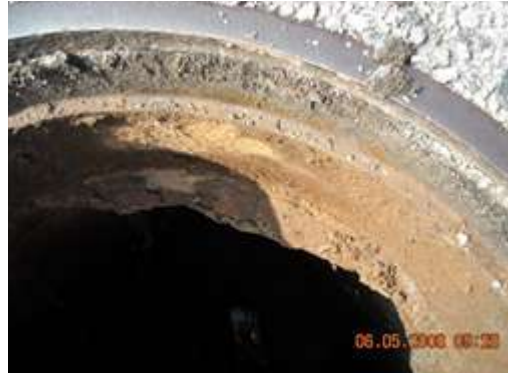
Defect 1

frame offset

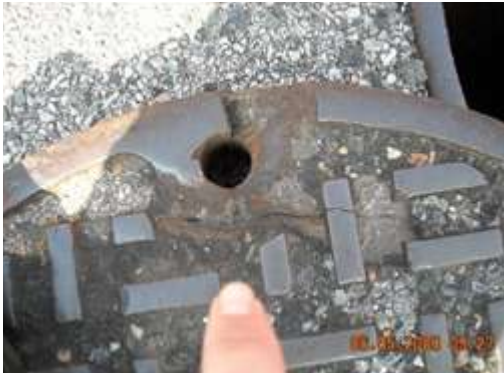
Type: **Sanitary** Condition: **Cracked** Cover Material: **Cast Iron**

cracked cover

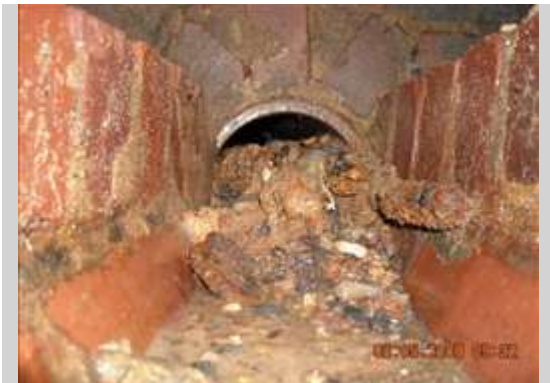
5 O'Clock Inflow

Pipe Height: **3.6** (in.) Rod and Bar (Angled)
Pipe Material: **Clay** ☐ Pipe Lined
Invert Depth: **0.00** (ft.) Flow Characteristics: **None**
Deposits: ☐ None ☒ **Mud** ☐ Sludge ☒ **Debris** ☐ Grease
Silt Depth: **7** (in.) Deposits Extent: **Heavy**
Infiltration: **None** Pipe Seal Cond: **Sound**

Connects To: **Stub connection / abandoned**
